AIRCRAFT ACCIDENT REPORT

WORLD AIRWAYS INC., FLIGHT 32,
MCDONNELL DOUGLAS DC-10-30CF, N112WA,
OVER NORTH ATLANTIC OCEAN
SEPTEMBER 20, 1981

NTSB-AAR-82-1
C. 2

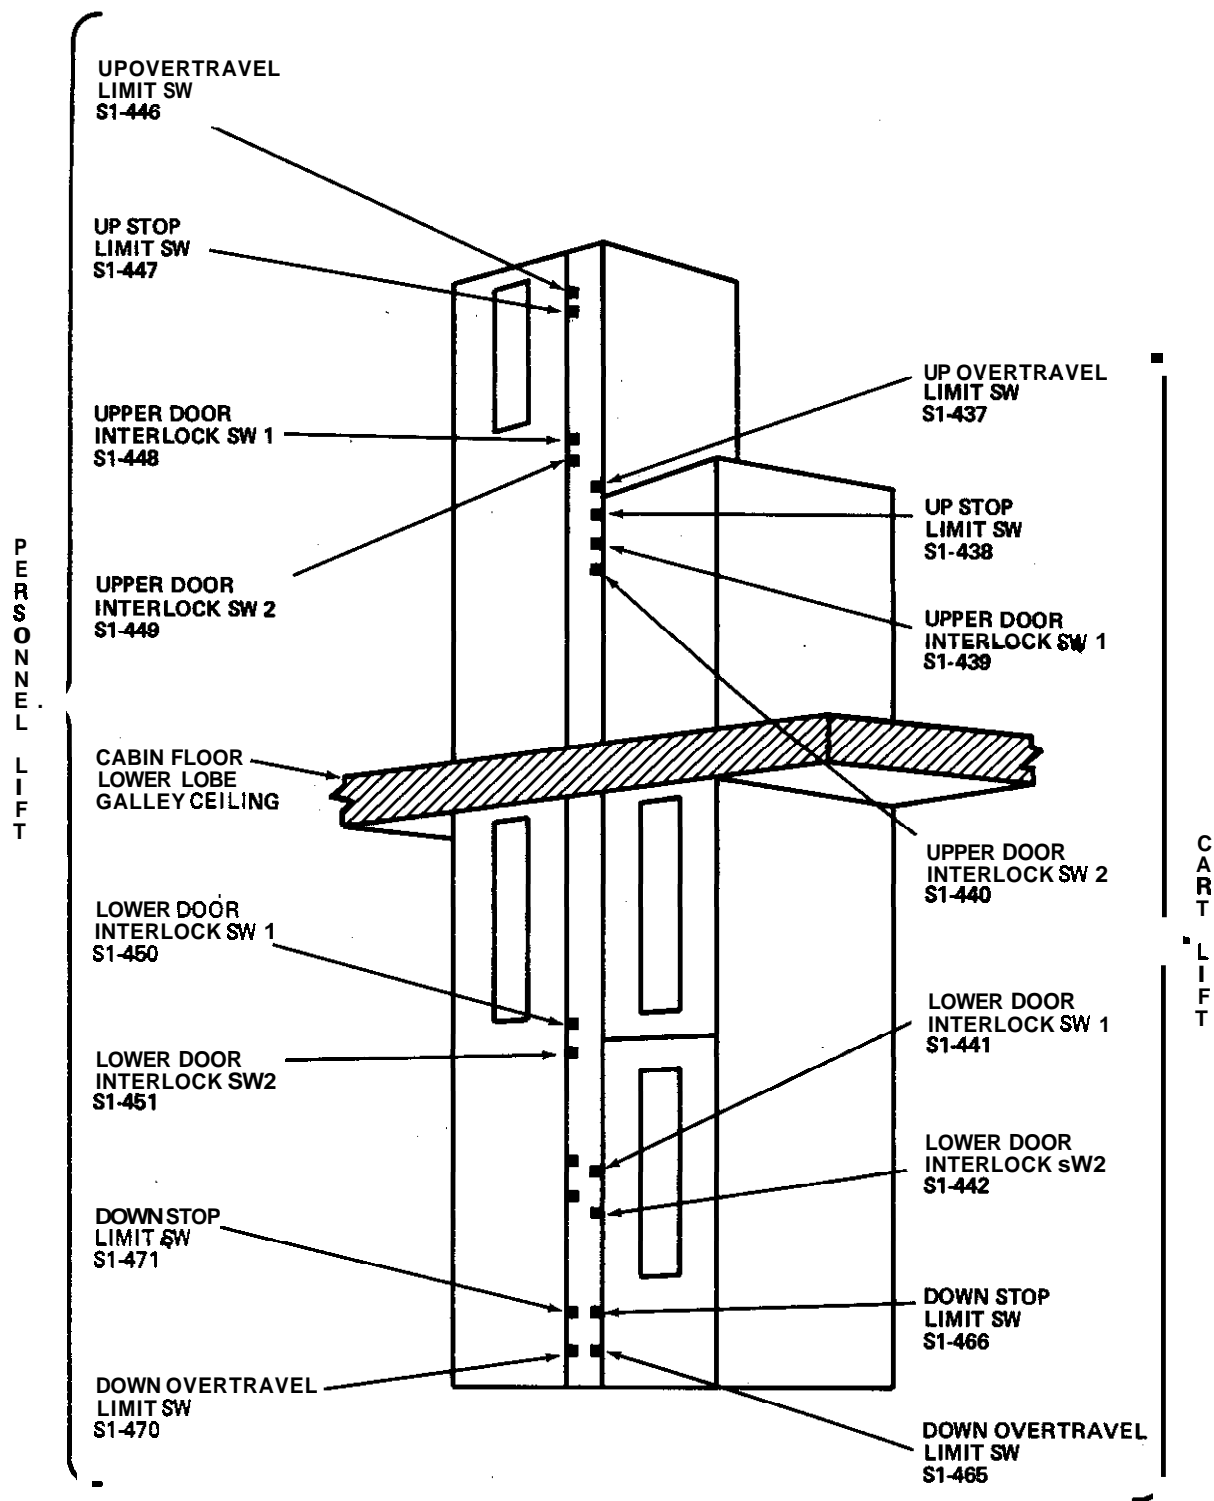
Figure 1.--Galley lift system with electrical switch locations.

Limit Switches - The range of travel of the lifts is controlled by limit switches installed within the wire duct attached to the forward side of one of the vertical lift tracks. There are two sets of two limit switches for each lift; one set located in the service center and one set in the lower galley. One switch is a normal stop switch and the other limit switch is **for** overtravel in the event the normal switch fails to operate. The limit switches are actuated by a cam plate mounted on the side of the lift. The cam plate has a machined offset to prevent actuation of the overtravel limit switch unless the normal switch fails to operate. In addition to the limit switches, mechanical stops are installed in the vertical lift tracks to stall and shut off the gear motors if both limit switches malfunction. (See figure 1.)

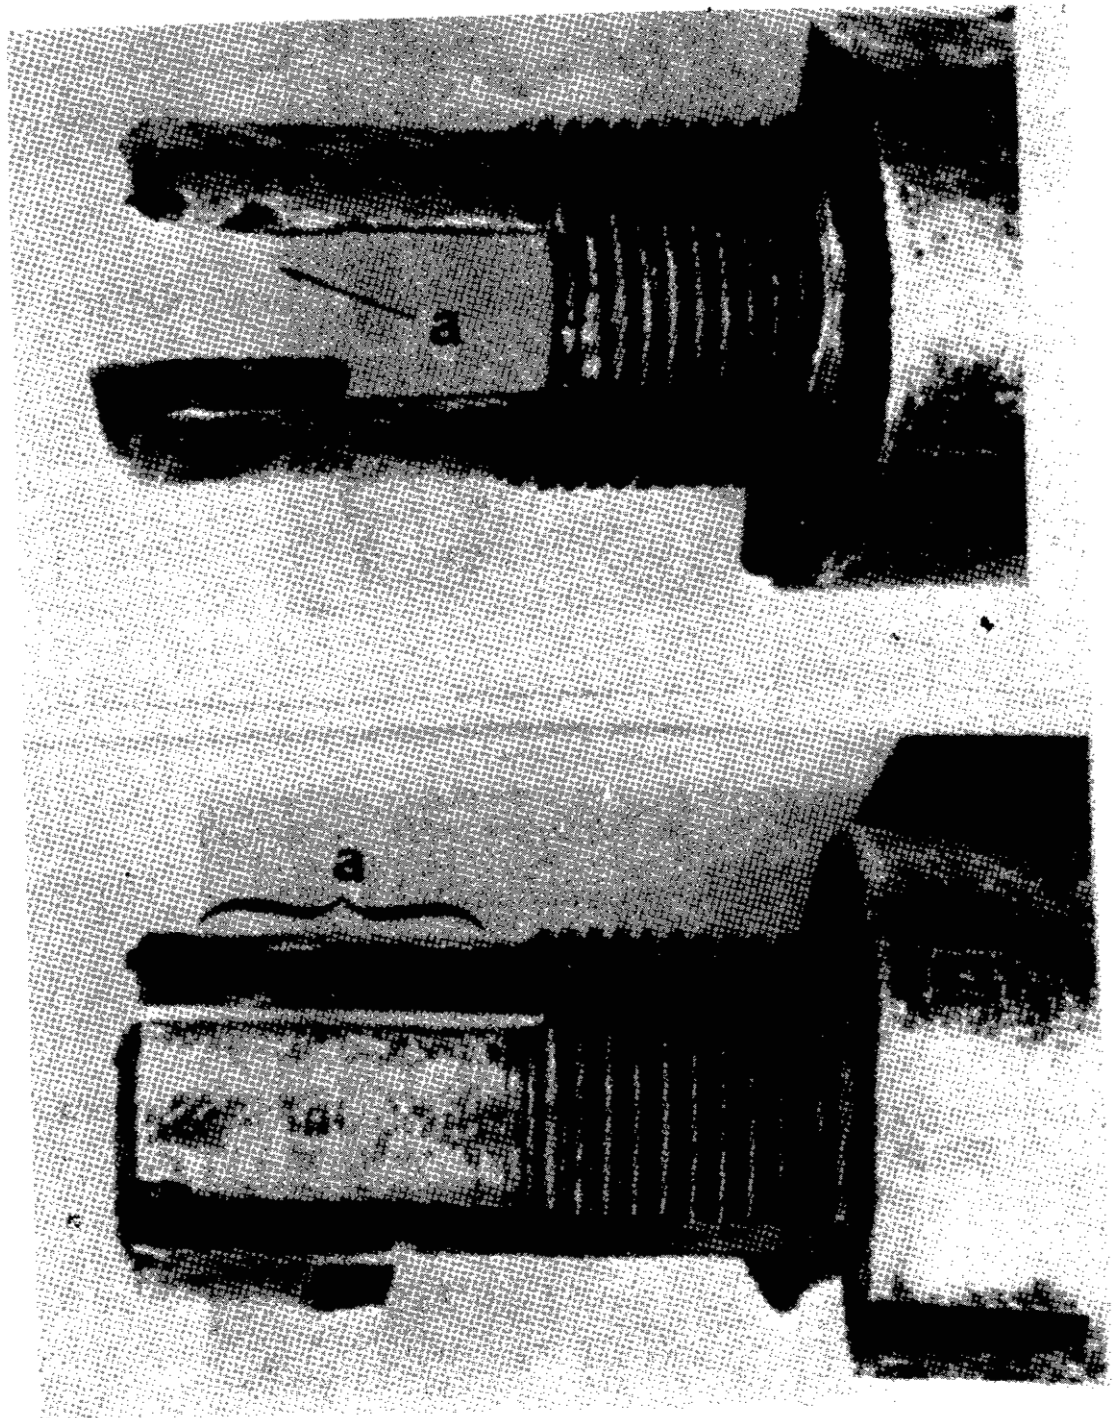
Figure 5.--View of switch assemblies.

Examination of the two personnel lift door interlock switch assemblies in the lower galley disclosed that the support brackets were bent. The bends were in a rearward direction and were 5° from centerline for the upper switch (S1-450) and 4° from centerline for the lower switch (S1-451). (See figures 5 and 6.)

In this accident, the Safety Board concludes that the deformation and subsequent jamming of the upper electric interlock switch (S1-450) on the lower galley personnel lift door was the direct result of damage to the door jamb area where the switches were mounted from recurrent contacts by galley carts. Although the deformation of the lower switch (S1-451) was of a lesser degree than that of the upper switch, the Board concludes that the damage to this switch was sustained under similar circumstances and caused intermittent jamming in the "closed" position. This conclusion is based on the results of the operational check at Gatwick after the accident, which disclosed lift operation at a normal speed with the lower galley personnel lift door open and the upper service center personnel lift door "closed." Electrical power to both personnel lift AC motors would have been necessary to cause the lift to operate at normal speed. This could only occur if both switches were closed. The results of the metallurgical examination of the switch assemblies further corroborate a probable malfunction of both switches at the time of the accident. The catering representative's statement that the lower galley lift door interlock switches had to be depressed in order to operate the lift cannot be reconciled with other evidence developed during the investigation.

Require a redesign of the DC-10 aircraft galley personnel and food cart lift doors and door frames to relocate the interlock switches to a position where they will not be susceptible to damage by food service carts, to inadvertant contact by personnel attempting removal of food service carts, and to contamination by foreign substance. (Class I, Urgent Action) (A-81-126)

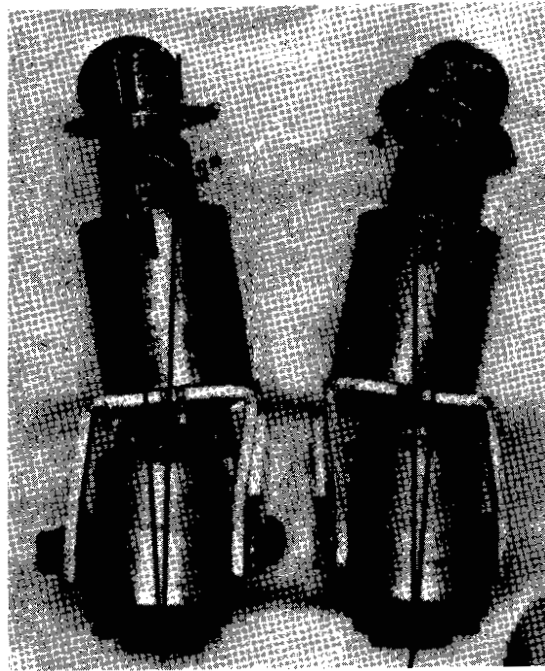
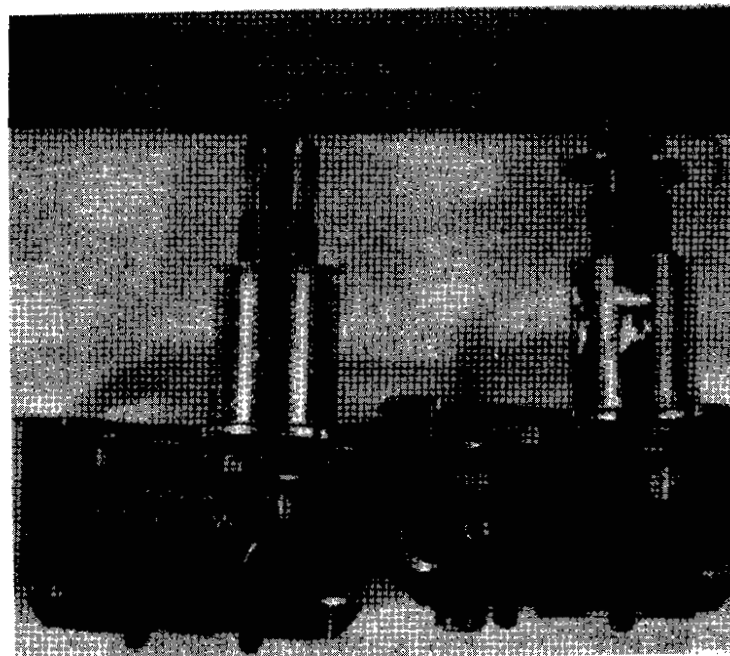
Figure 6.--Side view of S1450 (a) and SI-451 (b) switch assemblies, showing degree and directions of bending.

Other malfunctions of the interlock switches have been caused by mechanical damage. It was found that the door jamb and door frame structure on the lower level galley personnel lift is subject to repeated contacts by galley carts in the general area where the interlock switches are located. Examination of the galley lift door interlock switch assemblies revealed bending of the support brackets in a rearward direction.
